FATIGUE BEHAVIOUR OF A ROLLED AZ31 MAGNESIUM ALLOYS PREPARED BY EP AND BB CONDITIONS

Faculty of Engineering and Materials Science, German University in Cairo, Cairo.

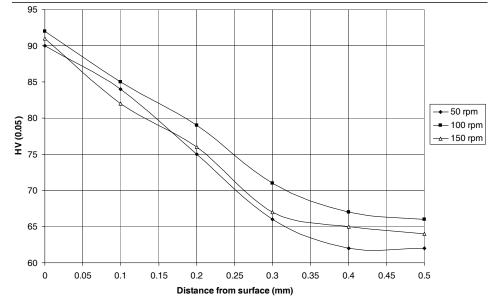
Fig. 3. Microhardness profile oif AZ31 after BB at 200 bars, 0.17 mm/min at different BB rotation speed.

3. 3. A different experiment were used to investigate the best condition for BB (pressure, feed rate, speed) as example for tool HG3 200 bar (123 N) for 50, 100 and 150 rpm. The microhardness measurement from the surface in Fig. 3. Shows that the suitable condition for using 200 bars is 100 rpm for AZ31 as the hardness decreased from the circumference gradually to the center.
