# FATIGUE BEHAVIOUR OF A ROLLED AZ31 MAGNESIUM ALLOYS PREPARED BY EP AND BB CONDITIONS

**Abstract:** Rotating bending fatigue tests have been performed using smooth specimens of a rolled AZ31 magnesium alloy in laboratory air at ambient temperature. Fatigue strength and characteristic was evaluated and fracture mechanism was discussed on the basis fracture surface analysis. Electrical polishing (EP) as well as deep rolling (ball burnishing (BB)) U-notched specimens were performed on two groups of samples, to evaluate optimum conditions for fatigue life. The microstructure and tensile properties of roll cast (RC) Mg- 3% Al- 1% Zn (AZ31) was investigated. The fatigue strength of 107 cycles around 100 MPa for deep rolling while it was around 40 MPa for Electrical polishing. It was very important to understand the effect of (ball burnishing (BB)) conditions on the hardness of the surface through to the core. The two procedures improved the fatigue performance, but better improve in results were found in ball burnishing. The growth of small cracks initiated at the surface coincided with the FCP characteristic after allowing for crack closure for large cracks, but the operative fracture

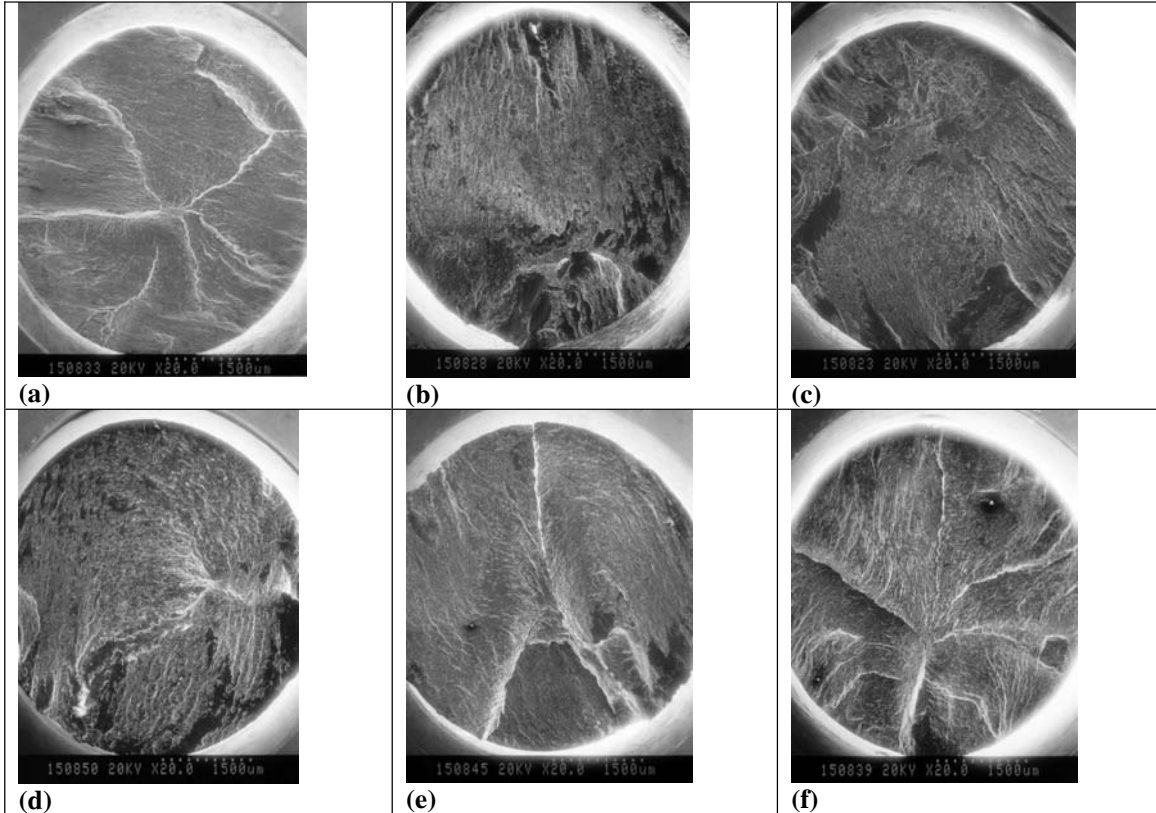
**Fig.4.** SEM micrographs showing fracture surfaces at difference stress for EP at (a) 60MPa; (b) 80 MPa; (c) 100 MPa and BB at (d) 60MPa; (e) 80 MPa; (f) 100 MPa.

The fracture surface of AZ31 for EP condition and BB condition at different stress is shown in Fig.

4. Subsurface crack initiation occurred at applied stresses at 60 MPa. At BB condition but it can be seen for both 80 and 100 MPa stress for EP condition. The S-N diagram is shown in Fig. 2. It is well known that fatigue limit does not exist in non-ferrous alloys, thus fatigue tests were continued until  $10^7$  cycles. At EP condition  $\sigma = 40$  MPa, fatigue failure did not occur, but non-propagating cracks were observed on the specimen surface. As can be seen in the figure, the present Mg alloy seems to possess a definite fatigue limit, which may be related to the existence of non-propagating cracks. The fracture mode depending

on applied stress level, above 60 MPa cracks initiate at the surface (surface fracture), while below that stress at the interior of the specimen (subsurface fracture). Subsurface fracture is a very interesting finding, which has not been recognized in Mg alloys, for both EP and BB conditions.
